# **Hydrographic Survey**

**Encina Marine Oil Terminal Decommissioning Project  
Carlsbad, CA**

## **Report of Survey**

Pre Decommissioning  
October 18th 2017

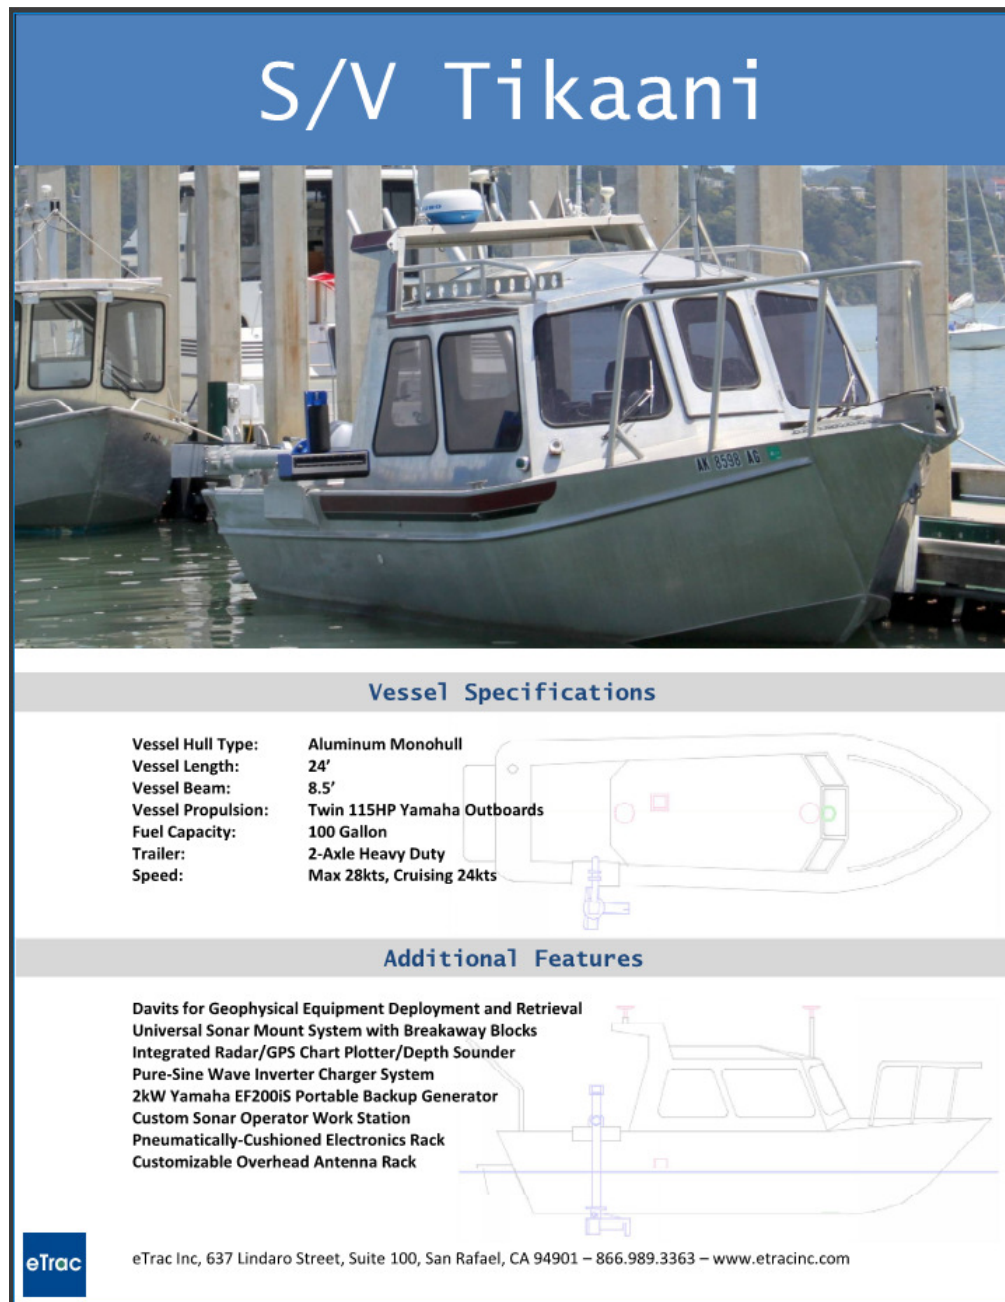
**Figure 2 SV Tikaani specifications**

All work was completed onboard survey vessel *S/V Tikaani*. *S/V Tikaani* is an aluminum monohull, hydrographic survey vessel of 24ft. *S/V Tikaani* is field proven, having conducted numerous hydrographic and geophysical surveys throughout Southern California with towed and mounted sensors. It is easily transported and can be mobilized for survey rapidly. A positioning and motion detection system was installed on the vessel with a long antenna base allowing maximum heading accuracy and better results in areas with low GNSS coverage. Tikaani had all offsets on the vessel measured while on a trailer to ensure that measurements to and from the positioning equipment are accurate to less than 3cms. The vessel is equipped with a Universal Sonar Mount (USM) for side-mounted multibeam. The multibeam system was mounted on this specially engineered side mount. This mount positions the system with 100% repeatability and allows for surveying in shallow water due to a specifically designed break away block (see Figure 2 for Tikaani specifications)

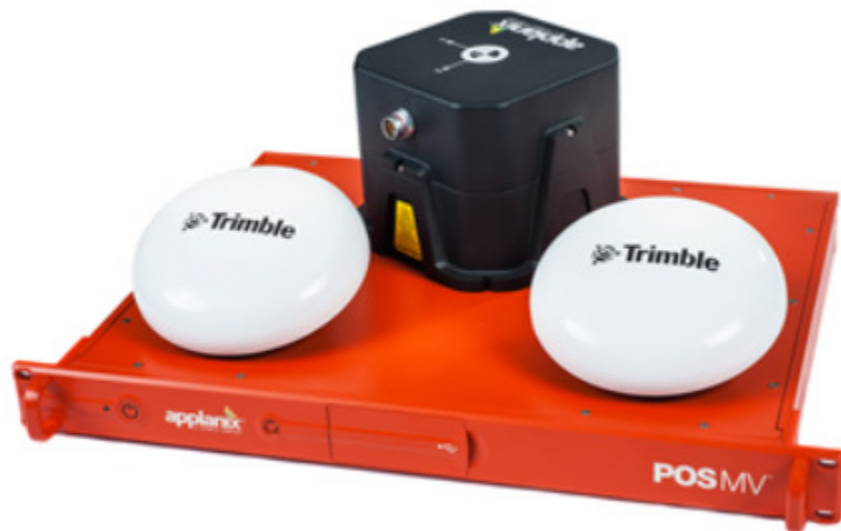
Figure 3 Applanix POS MV Oceanmaster

- Position Accuracies PPK: Horizontal: +/- (8 mm + 1 ppm x baseline length)<sup>3</sup>  
Vertical: +/- (15 mm + 1 ppm x baseline length)
- Motion Accuracies, Roll and Pitch: 0.015° in PPK
- Heading Accuracies: 0.03° (2 m baseline)
- Real time Heave 5cms and Trueheave Solutions available increasing to 3cms
- With POSPac Processing allows PPK solution with GLONASS AND GPS satellites.

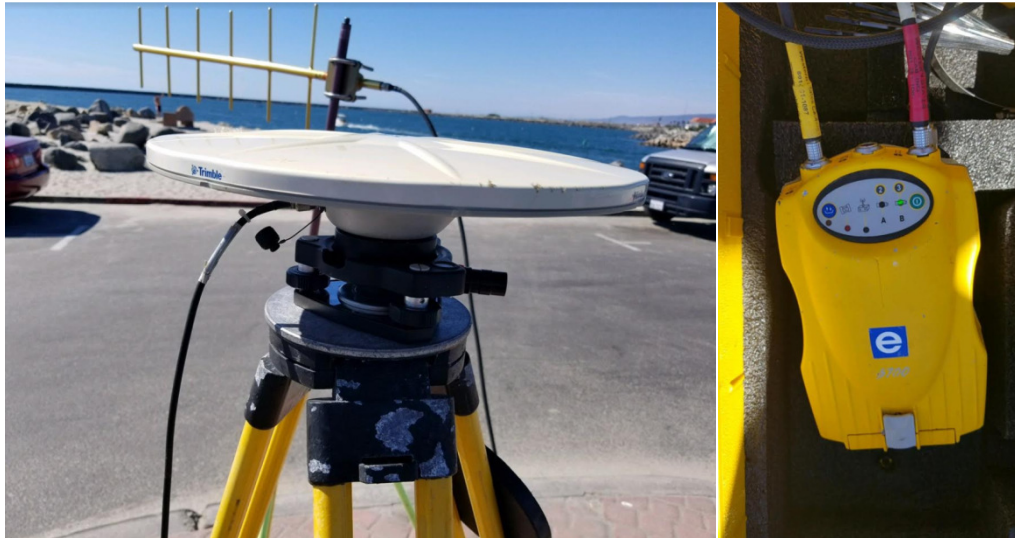
**Figure 4 Trimble SP 5700 RTK base station set up for the project**

A base station was set up next to the survey area in Oceanside with a baseline no longer than 20 miles to any point in the survey area. This base was constantly logging and broadcasting correction data. The base position was set up on a known USACE benchmark referenced to Mean Lower Low Water (MLLW) in Oceanside. The system provided corrections for GLONASS and GPS satellites for optimal performance in areas where satellite could be blocked such as under the bridges. Precise positioning and motion systems as well as a high resolution multibeam sonar were installed for this project and are described below.

- Broadcasting RTK CMR+ and CMR 94 corrections
- Logging data with NetR5
- GPS and GLONASS

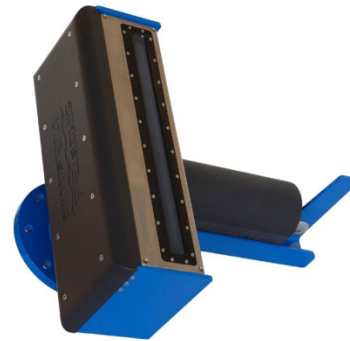
**Figure 5 R2 Sonic 2024 Multibeam Echosounder System**

- 450 kHz
- 256 discrete  $0.5^\circ \times 1.0^\circ$  beams (1024 soundings with ultra high density mode implemented)
- 1 to 500 meter minimum/maximum range
- 1.25 cm range resolution

An R2 Sonic 2024 multibeam system was used for all data. The system was run at 450khz in ultra high density mode. This allowed sounding data density to be four times that of the standard R2 sonic 2024 system. The system was run with no gates or filters to enable imagery of all potential objects in the entire water column.

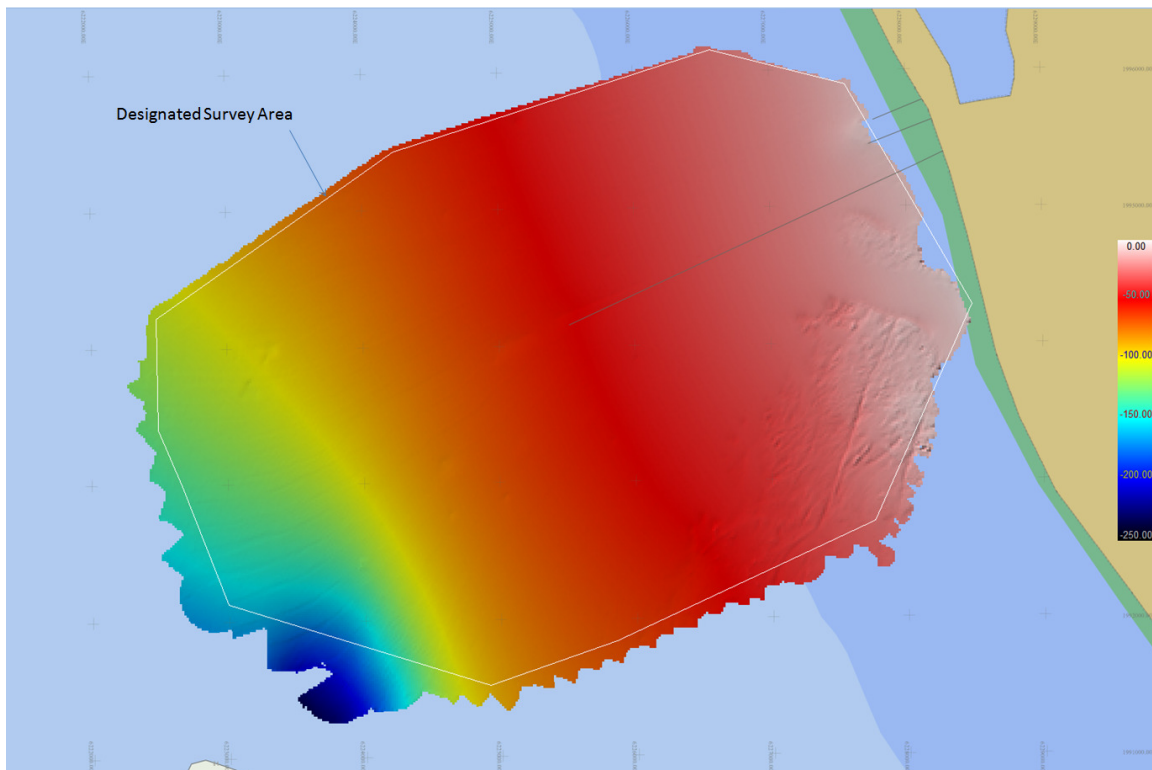
**Figure 9 Multibeam coverage**

200% multibeam coverage was achieved in entire survey area. All the position data was successfully post processed so that up to 100% of the data was post processed kinematic where accuracies of 0.1ft were achieved.

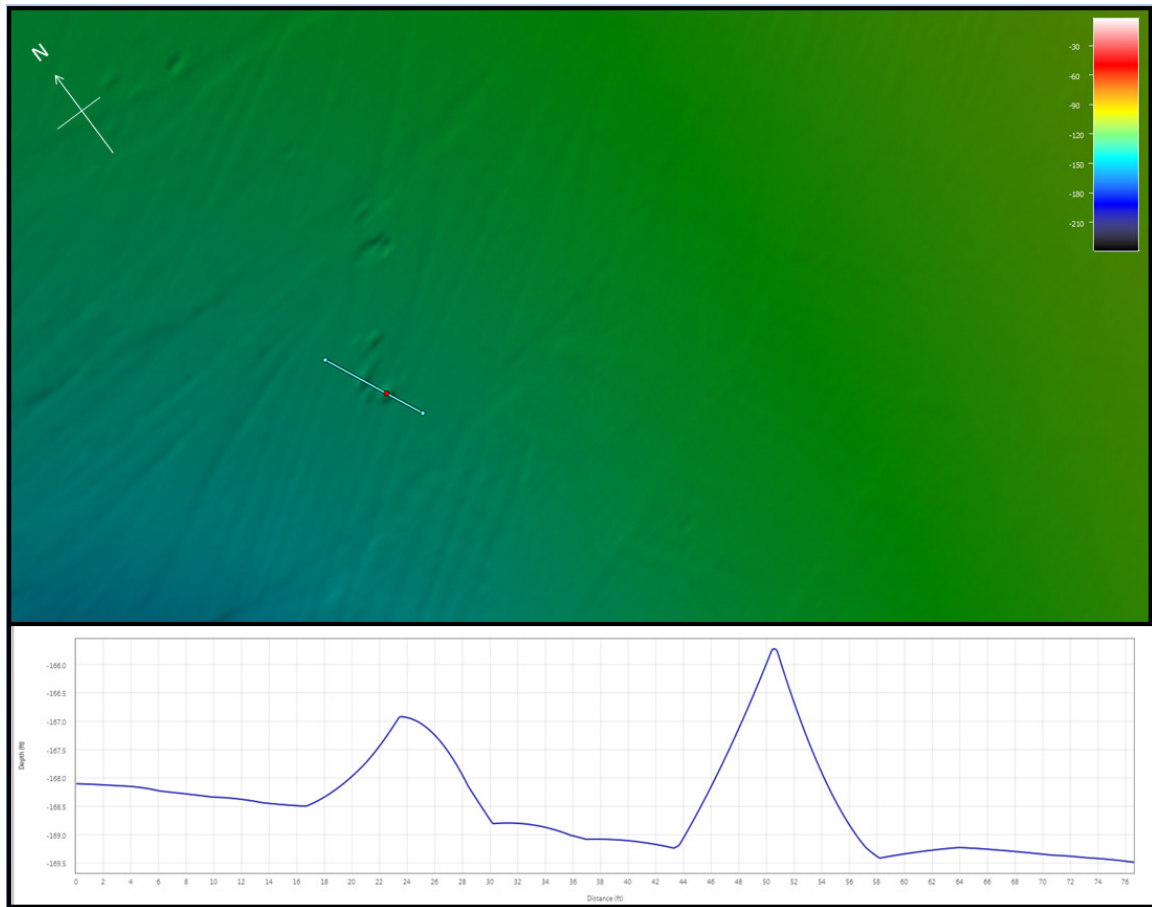
Data resolution and density was such that objects 6ft wide were detected past 100ft. The smallest note worthy object detected was 4x3x1ft. Rocks with diameters of 3ft were detected down to 170ft (see Figure 11).

**Figure 11 Rock objects at 168ft depth**

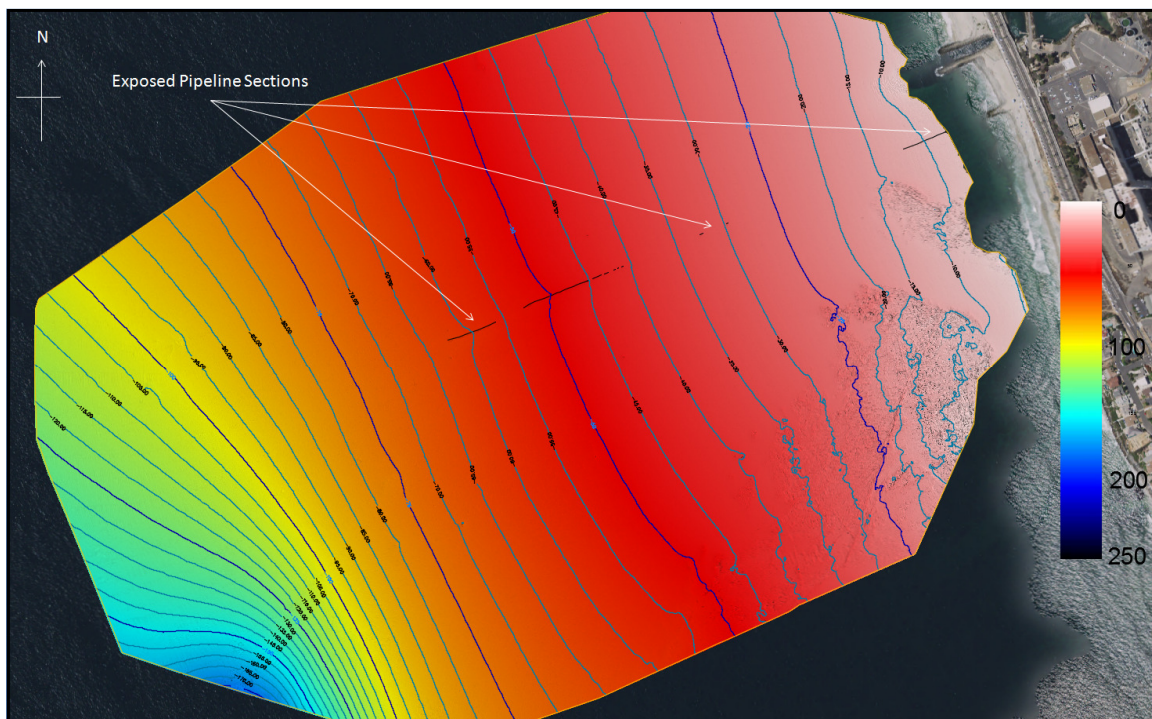
**Figure 14 Pipeline exposure sections**

The pipeline was observed as being exposed for 1098ft. There are eight (8) exposure sections ranging from 8ft to 421ft. As the pipeline transitions from sea to land the pipe was mapped up to the shallowest point. The pipeline is exposed during this transition from water to land. These sections are shown below in Figure 14.

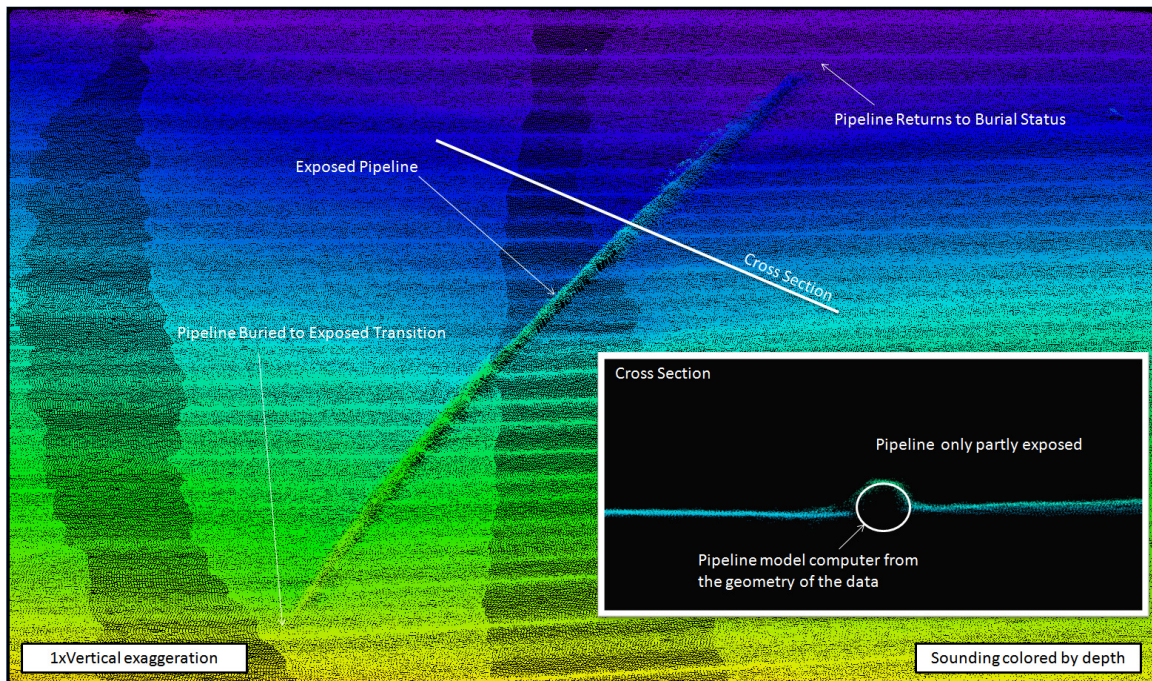
During the transition from water to land the pipeline is exposed and further exposure sections are offshore. The pipeline is not fully exposed. Only part of the pipeline was visible above the surface. The pipeline, as seen in the multibeam data as a 3D point cloud is shown in Figure 15 below. The pipeline in the transition zone is shown in Figure 16. The curved geometry of the pipeline is evident which allows the determination that the pipeline is not fully exposed.

**Figure 15 The pipeline in 3D point cloud data**

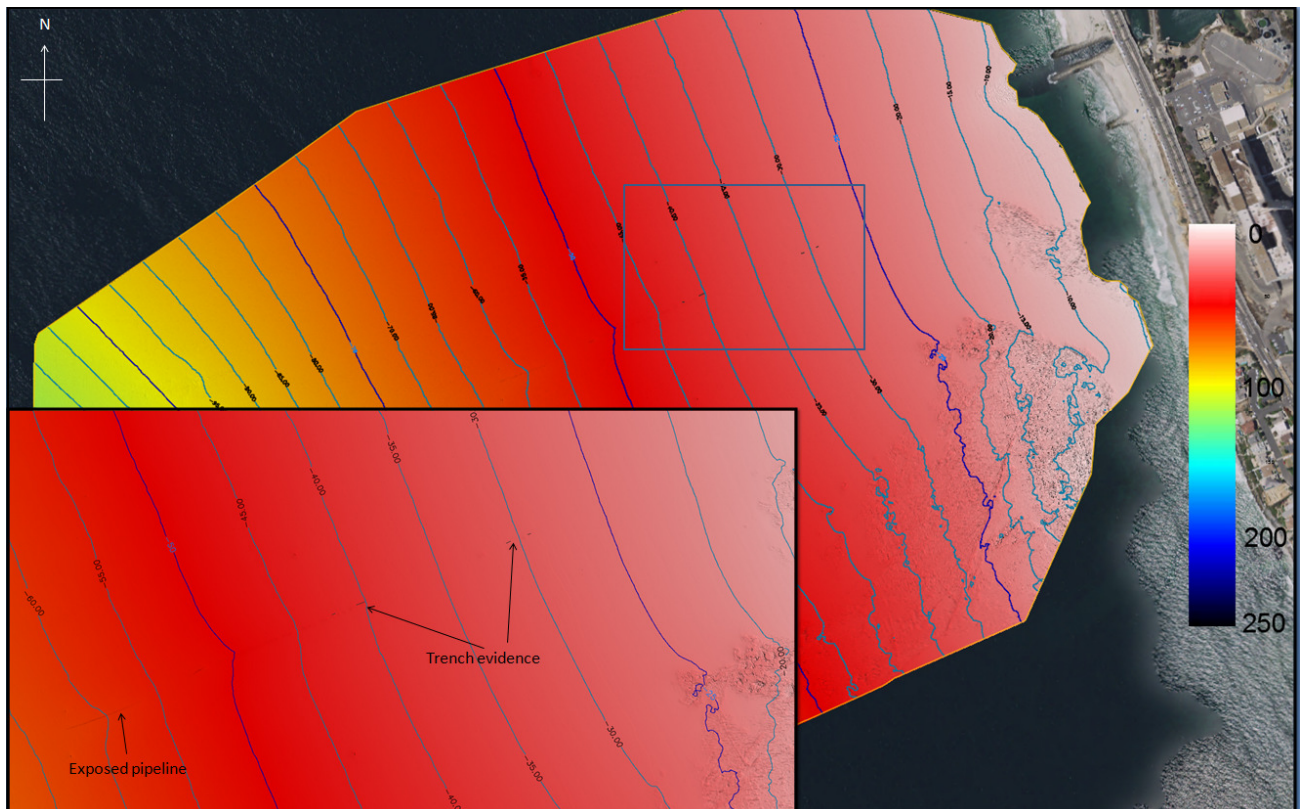
**Figure 17 Trench evidence sections**

In small areas the bathymetry resembles a pipe line trench or scouring. This is directly in line with and adjacent to the exposure sections. These trench feature lead from one exposure section to another. Therefore, these could be used as evidence of the horizontal alignment of the pipeline where buried.

These trench evidence sections are shown below in Figure 17 and Figure 18.

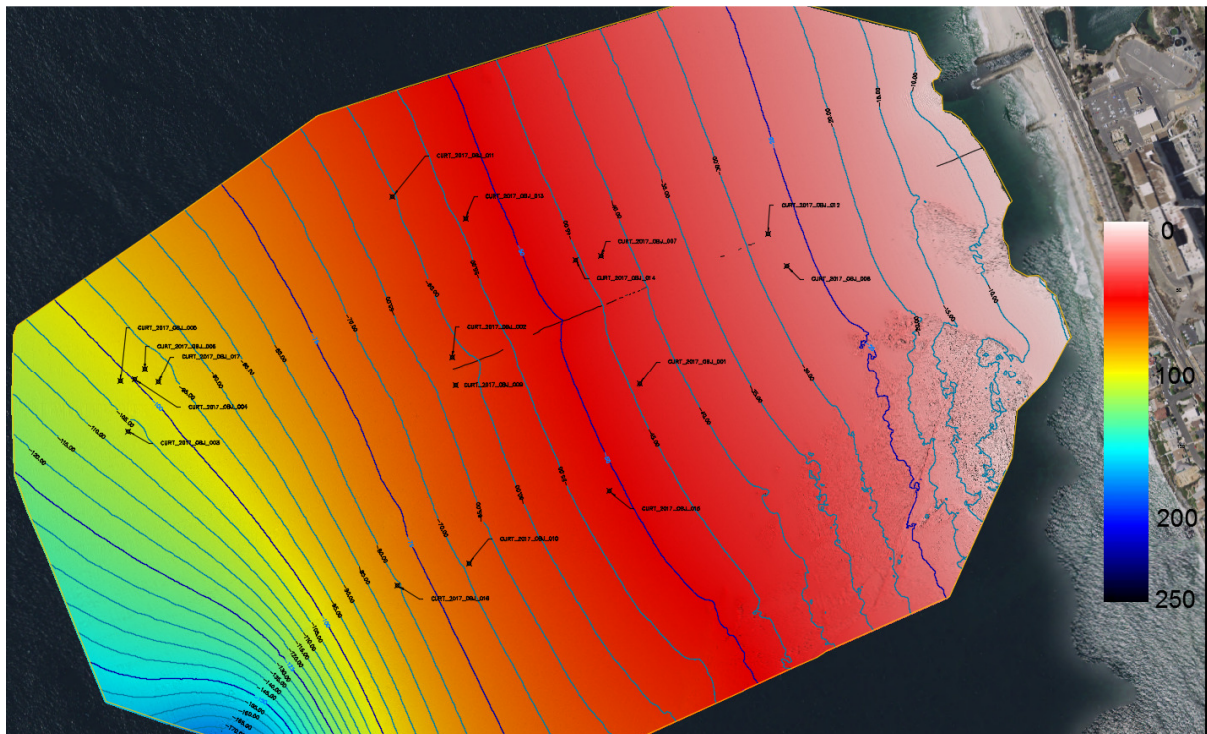
**Figure 19 Location of debris objects in the survey area**

Seventeen (17) debris objects were located in the survey area. These range from 10ft long to only 4ft. A comparison and correlation of the location of the debris objects, with the position of tanker berth mooring buoys and pipeline end anchors as located in the drawing 12-011-D-01 rev 4 drawn by Longitude 123, inc on October 2nd 2013, suggested that the debris objects were possible anchors. Table 1 below lists the debris objects located. The details column shows that many of the objects are possible anchors due to their correlating position with that shown in plot as well as the feature geometry.

Below in Figure 19 the location of all the objects relative to the pipeline can be seen. Figure 20 shows an image of drawing 122-011-D-01 rev 4 with mooring and pipeline anchors for comparison.

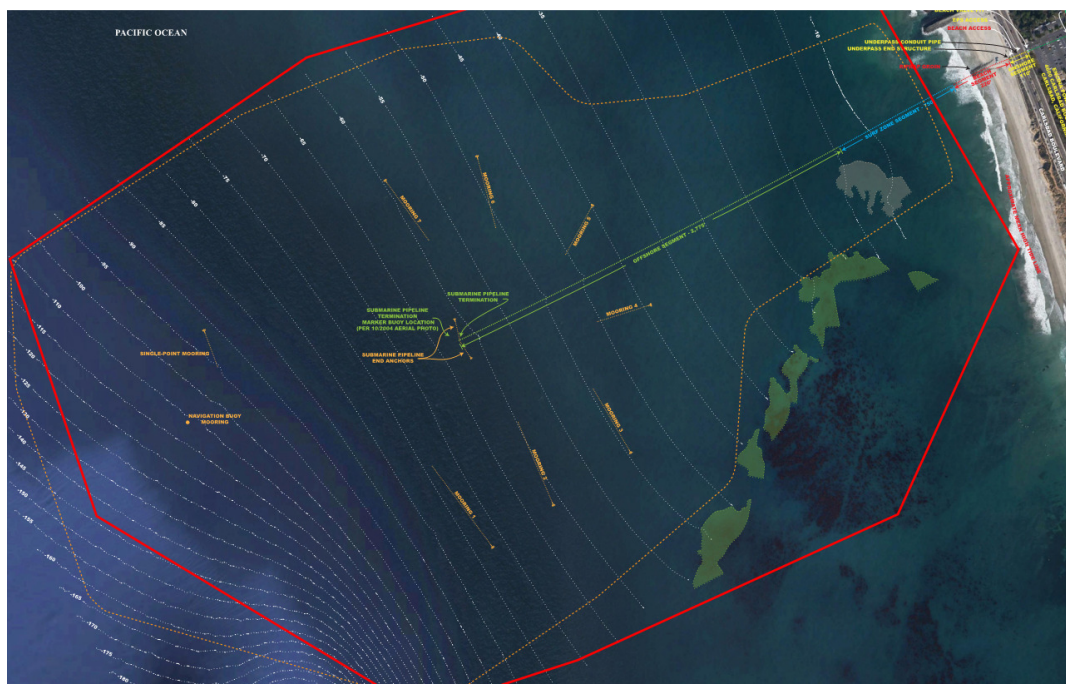
**Figure 20 Image from the drawing 12-011-D-01 rev 4 showing mooring and pipeline anchors**

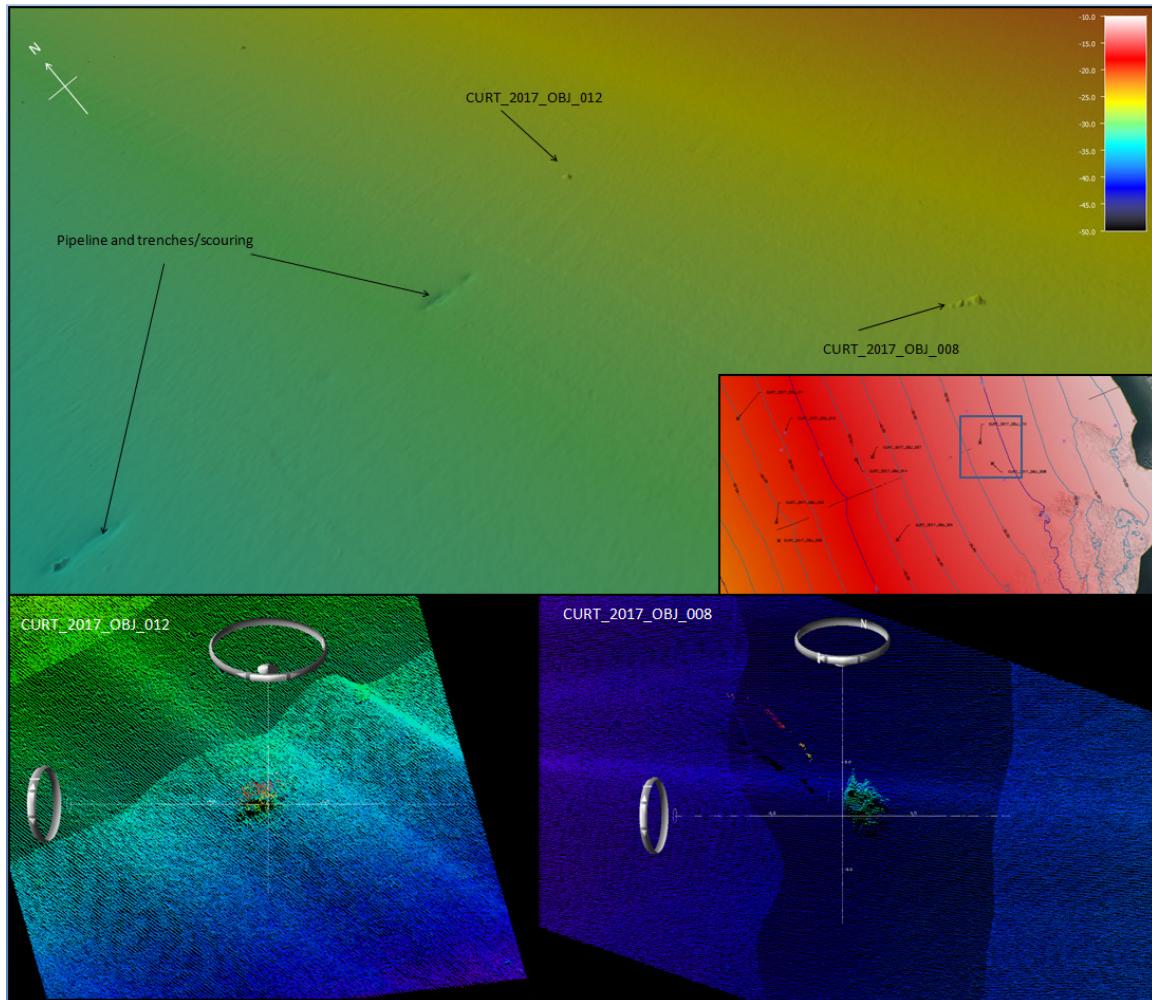
The location of two (2) objects, CURT\_2017\_OBJ\_012 and CURT\_2017\_OBJ\_018 did not correlate to any of the mooring or pipeline anchors. However, their position either side of the pipeline and shape (including evidence of an attached line) suggested these could be anchors or pipeline associated infrastructure (see Figure 24).

**Figure 24 CURT\_2017\_OBJ\_008 and 012 possible anchors due to shape and attached line**

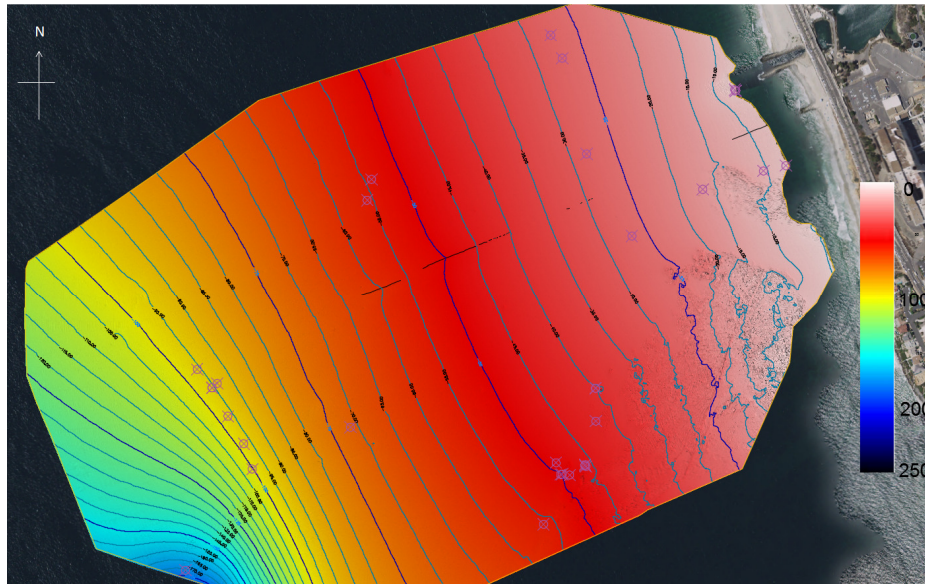
**Figure 25 Location of the 32 rocks in the survey area**

Thirty-two (32) rocks or boulders were located across the survey area. These are listed with unique IDs in Table 2. Sporadic, isolated rocks were located across the survey area. Several rocks were adjacent to the rock outcroppings in the south east of the survey area. The map in Figure 25 shows the location of the rocks across the survey area.

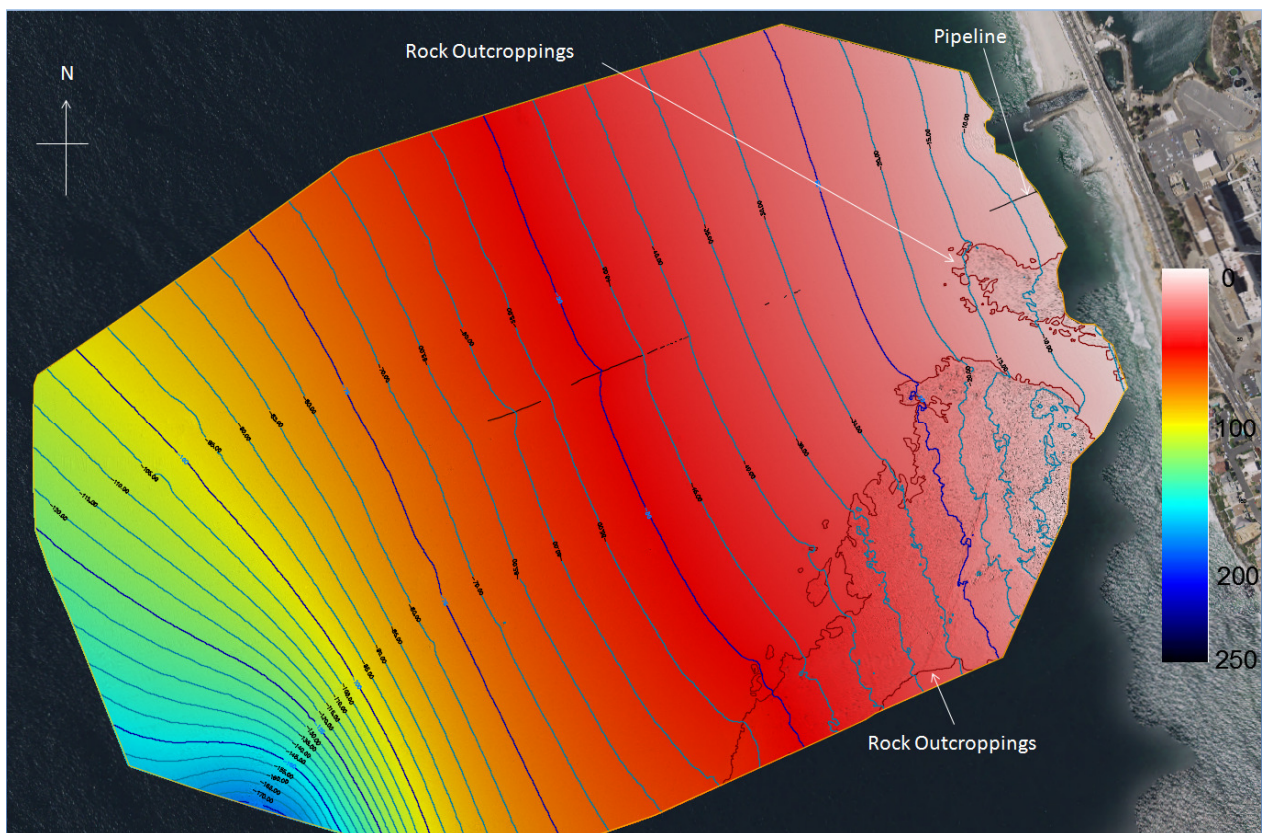
**Figure 27 Rock outcroppings in the survey area**

Rock outcroppings are located in two main areas. There is one large contiguous area of rock outcropping to the south and south west. This area covers 44 acres up to survey boundary (The area could extend further outside the survey boundary and to shore). Then there is a smaller area to the west. This is 3.3 acres in the survey area (The area could extend further outside the survey boundary and to shore). Smaller rock outcropping areas were identified adjacent to and less than 250ft from the larger areas. These were between 0.01 acres and 0.05 acres. The map below in Figure 27 shows these rock outcropping areas.

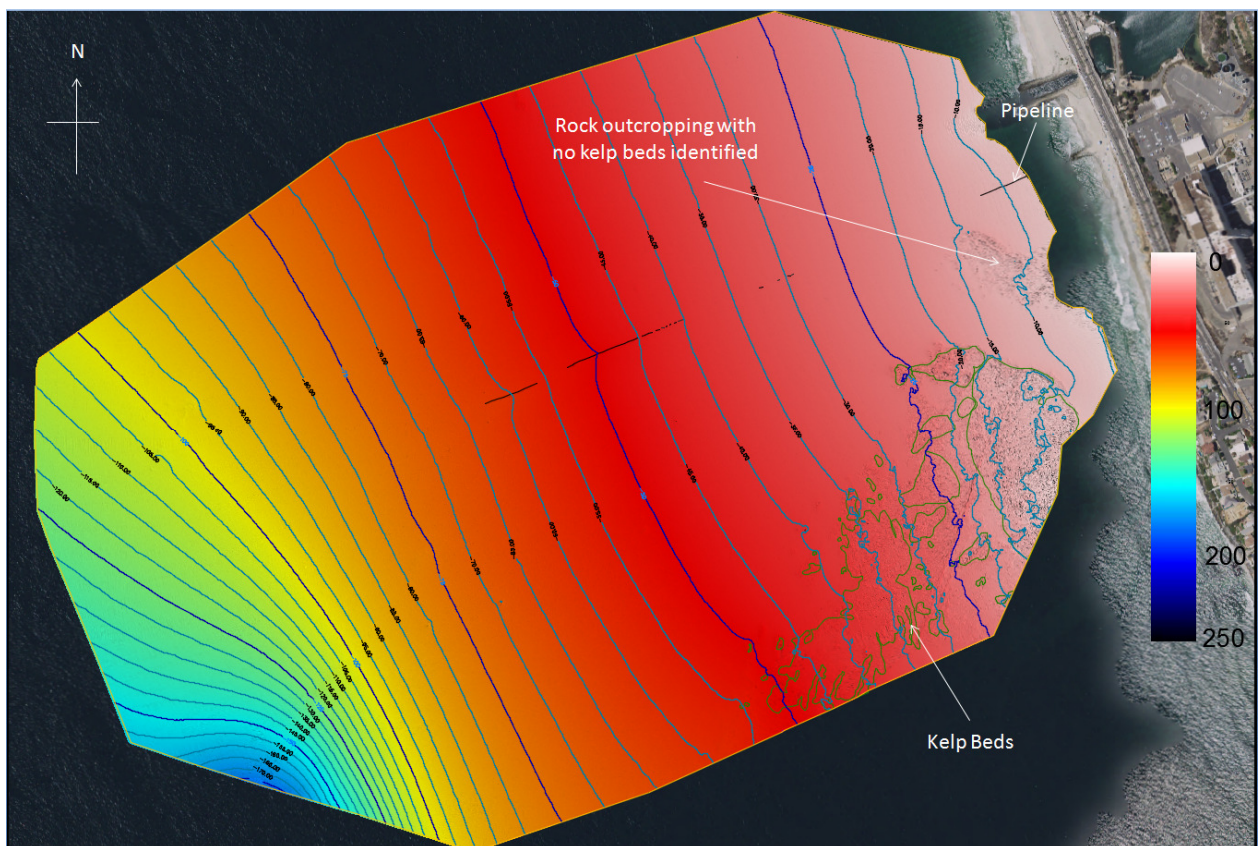
**Figure 28 Kelp Beds in the survey area**

The kelp beds detected correlated with the rock outcropping locations. While not all rock outcroppings were covered in kelp, all kelp beds were detected in rock outcropping areas. Kelp beds were detected on the larger rock outcropping area at depths of 15 to 50ft. No kelp beds were noted on the smaller, western rock outcropping area. The largest area of kelp was 9.5 acres. Smaller kelp beds around 0.05 acres were also identified on adjacent smaller rock outcropping areas. The map below shows the location of the kelp beds in Figure 28.

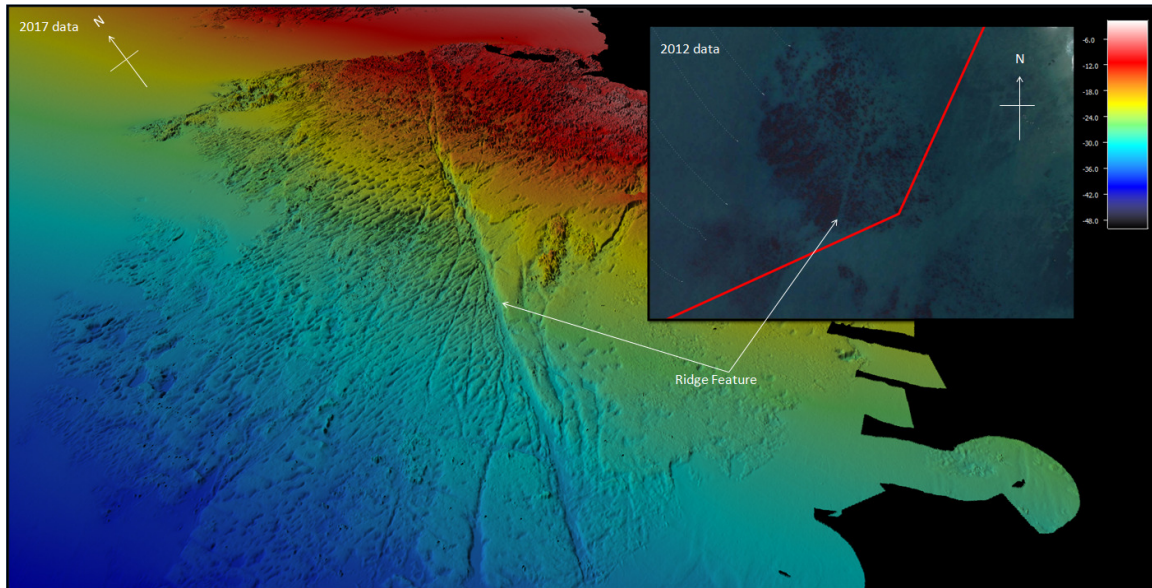
A ridge feature was evident in both the 2017 multibeam data and the aerial photography from 2012. The ridge feature is in the middle of the larger rock outcropping in the south west of the survey area. It is on average 1ft deep and 6ft wide and runs the entire length of the rock outcropping (1600ft). The ridge as seen in the multibeam data and aerial photography are shown below in Figure 32.

**Figure 32 Ridge feature as detected in the 2017 data and evident in the aerial photography in 2012**
